OSBMA School Bus Technical Update

Jack Szalka – Technical Support Manager - Bus

October 21 2020

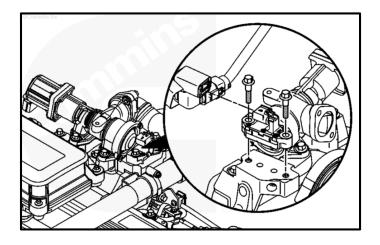
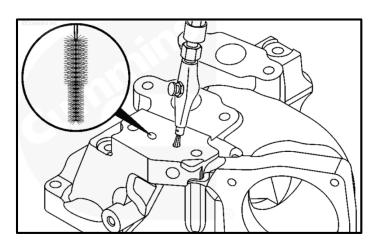
Cleaning EGR differential sensor and ports:

- Packed or dirty EGR diff sensor and ports can create downstream issues in aftertreatments
- Look at intake air connection for EGR diff port cleaning
- EGR Valve cleaning procedure can be found in procedure **011-022 EGR Valve**
- Differential Port (DP) cleaning procedure can be found in procedure 010-080 Air Intake Connection – Also 5579934 bulletin
- Benefit of **5000 hour** cleaning will **reduce bus downtime** due to EGR DP port and sensor related **faults 3382, 1921, 1896, 3375**.

- · EGR flow measurement by the ECM is accurate when the intake air connection exhaust gas entrance ports are clean or lightly sooted.
- EGR differential pressure sensor ports/cross drillings need to be maintained in a clean condition to ensure that EGR flow measurement by ECM is accurate.

- · Air Intake Connection exhaust gas entrance ports and EGR differential pressure sensor ports/cross drillings may accumulate moderate soot deposits that can change the ECM's EGR flow m accuracy.

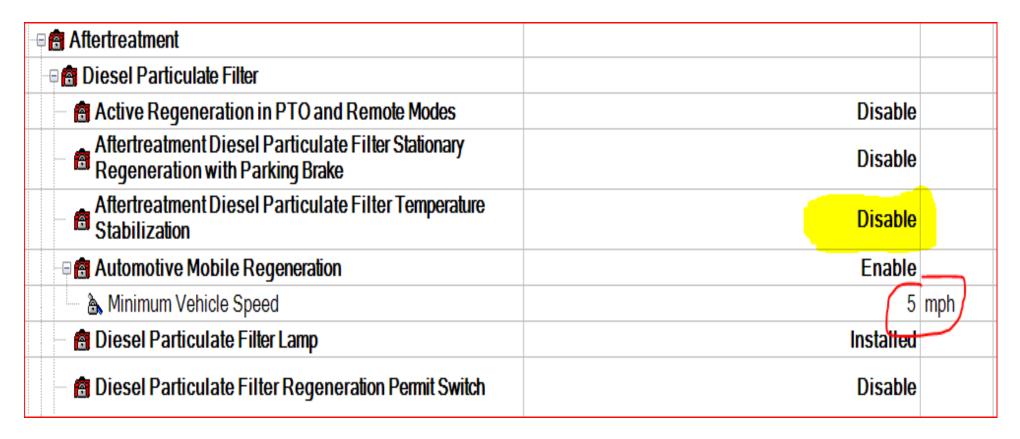
Mobile Regen Set Speed & DPF Temp Stabilization – Example – Insite General <u>Default</u> settings

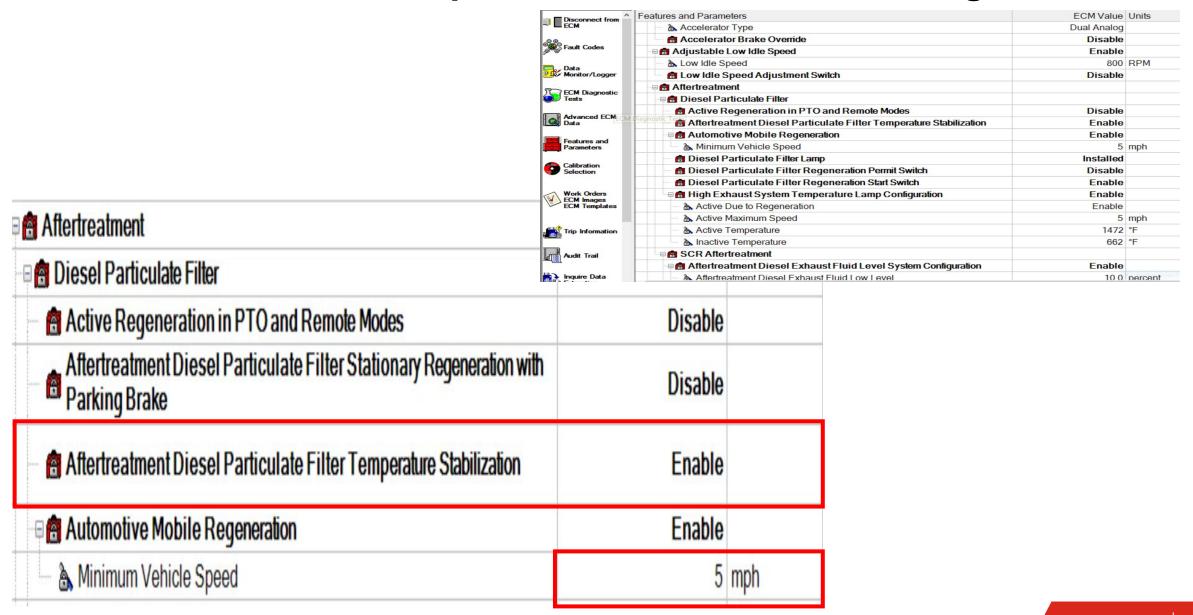
School Bus DPF & Temp Stabilization Feature Settings

■ The CM2250 & CM2350 engines have a DPF stay warm feature – aftertreatment temperature stabilization – Refer to TSB170058

TSB170058 ISB CM2250/CM2350 B6.7 CM2350	Aftertreatment Temp Stabilization Setting The temp stabilization feature should be enabled on any school bus that has the minimum regen road speed set above zero .
TSB190012 B6.7 CM2350	ECM Calibration update to correct turbo compressor side oil leak – C2191 ECM calibration campaign was released 8/24/19
TSB190165 B6.7 CM2350	FC 3383 Soot deposits in the intake air connection exhaust gas entrance ports are present and have affected EGR flow measurements. After troubleshooting and inspection If ECM calibration code revision on unit was released prior to December 2018, calibrate the unit with the latest ECM calibration code revision. Also refer to campaign C2191
TSB190181 ISB CM2350	Exhaust Gas Recirculation (EGR) System Differential Pressure Sensor Incorrect Installation: Fault Codes 3361, 3389, 3382 and 3383 – Shows correct orientation of EGR differential sensor

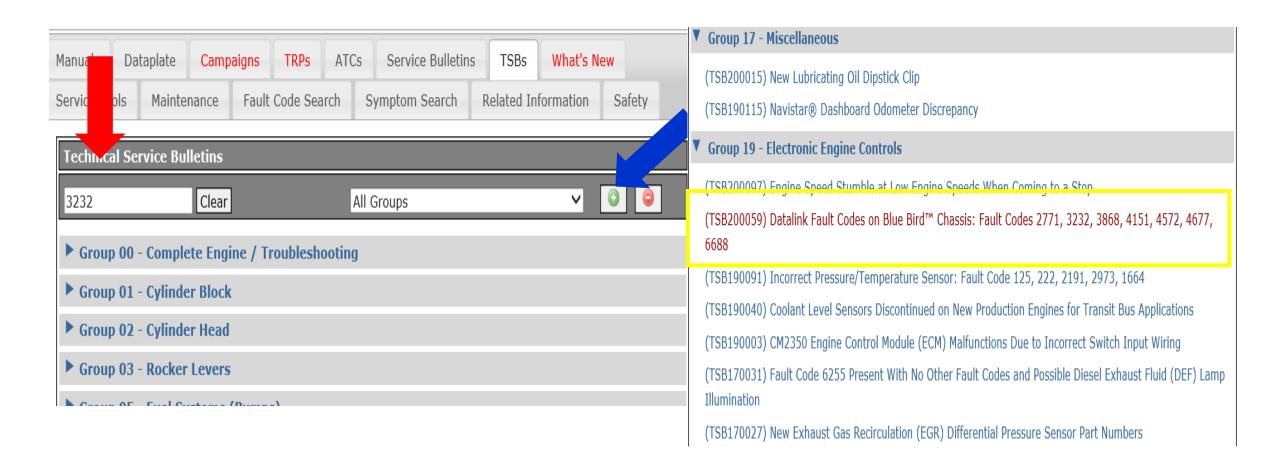
TSB – Search – Add key word or FC number in search box and hit enter Expand (green +) Search results highlighted in red that match you key word

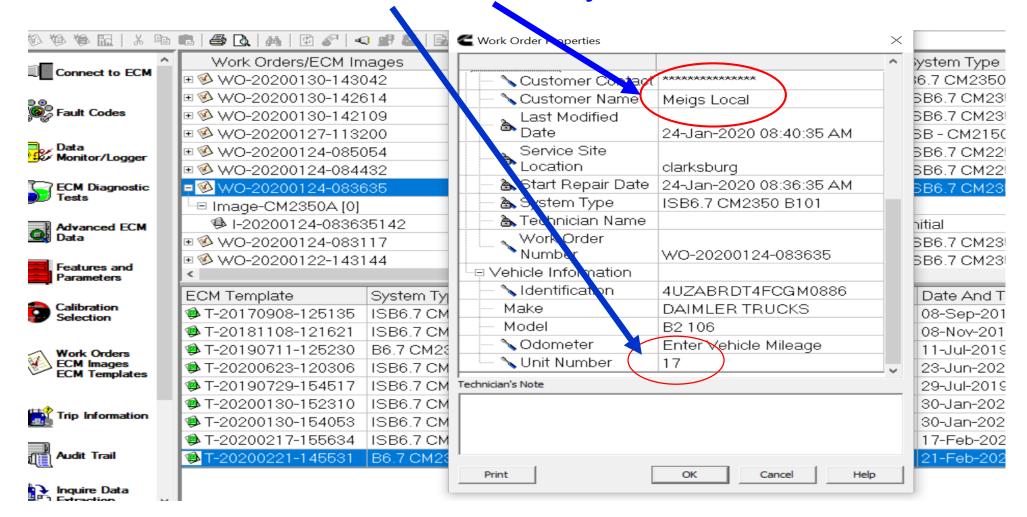
ALWAYS Create Insite Work Orders

PLEASE add the UNIT Number and Name to your work orders

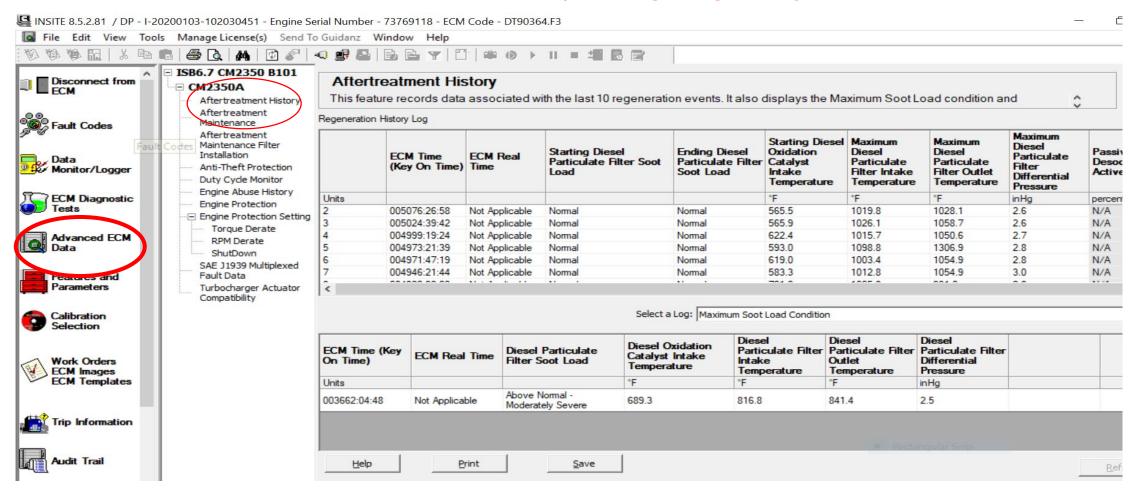
Regen History – Insite

The last 10 regens completed are stored in the Insite ECM image

> Advanced ECM Data – Aftertreatment History (Using image analyzer is much easier)

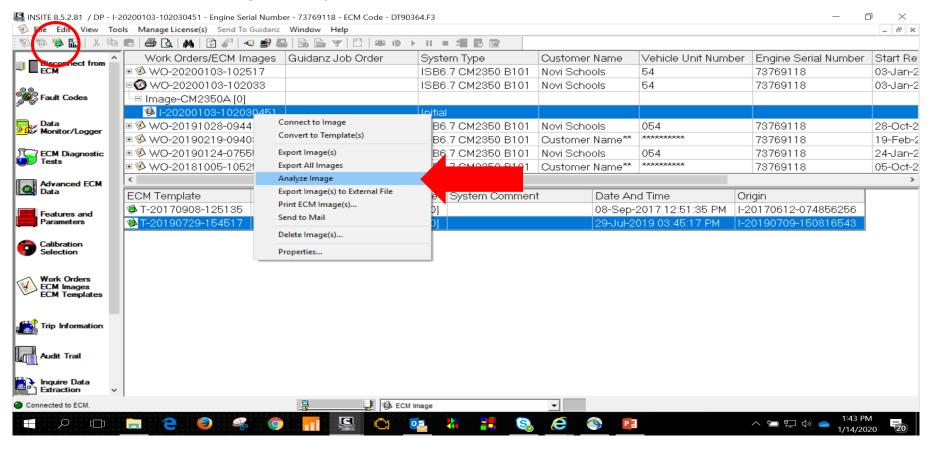
Regen History – ECM Image Analyzer

- ECM image analyzer is much easier to read and use It converts into an easy to read format
- You must have a ECM work order/image to convert
- Right Click the third line down on the ECM image or once third line is highlighted you can use the 4th Icon double click either and the ECM image analyzer will run
- It will open the image analyzer in multiple tabs

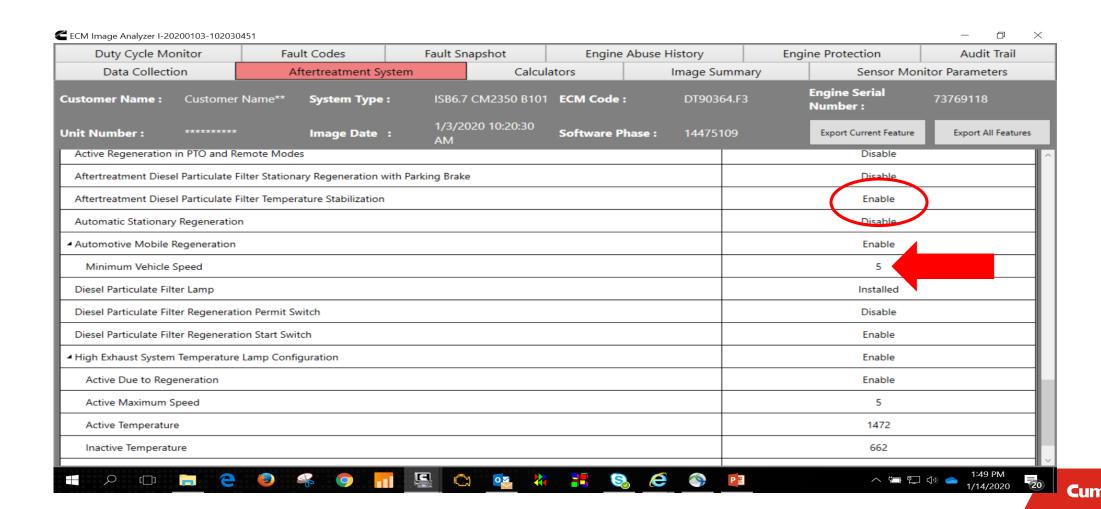
Regen Speed Settings – Image Analyzer – Quick look to verify settings are correct

Scroll down below the regen frequency to review how the vehicle is set up in features and parameters

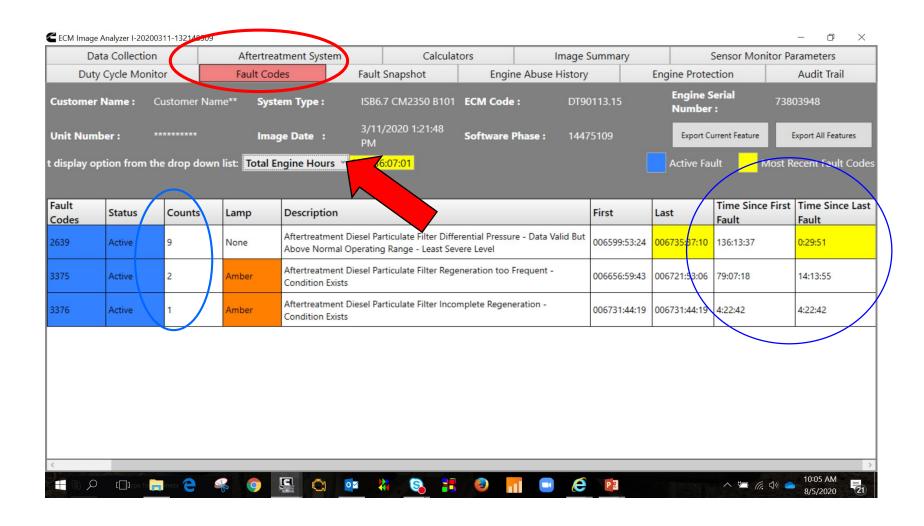
Click the Fault Code Tab – You can toggle to engine hours (from ECM time) Displays the time since first and time since last Fault code counts & Active Inactive

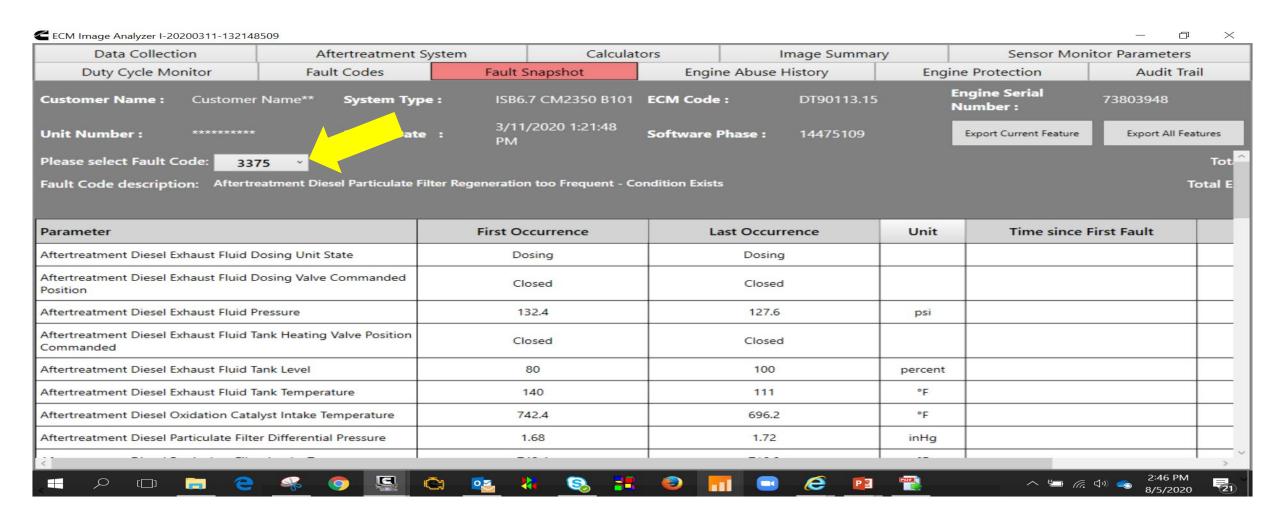
Fault Snapshot tab – Toggle between FC's to look at first and last engine parameter details when code(s) logged

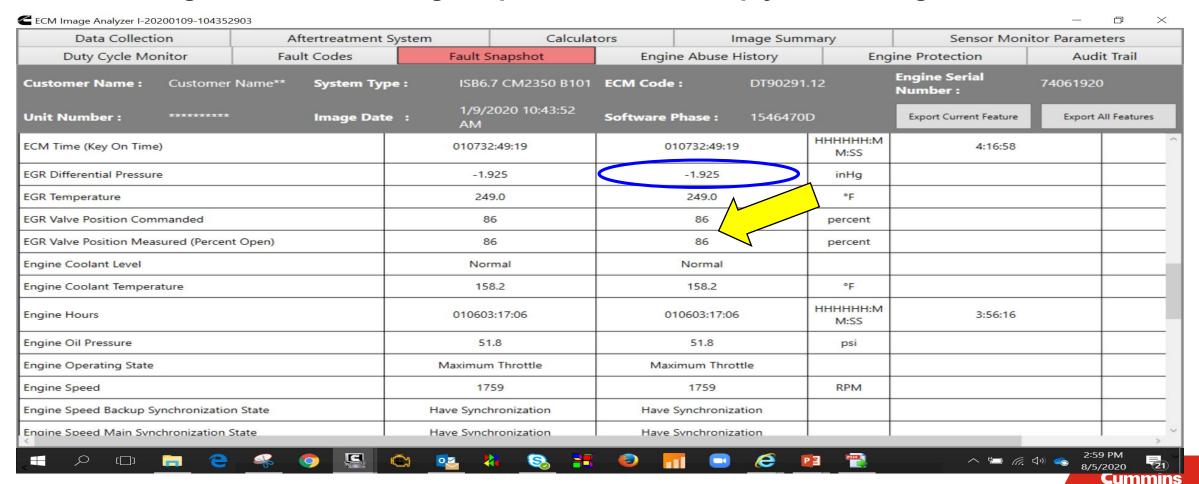
This example FC3382 snap shot data – EGR flow error

Note EGR is commanding 86% and flow is -1.9 – EGR port plugging?

Reviewing and understanding snap shot data can help your investigation

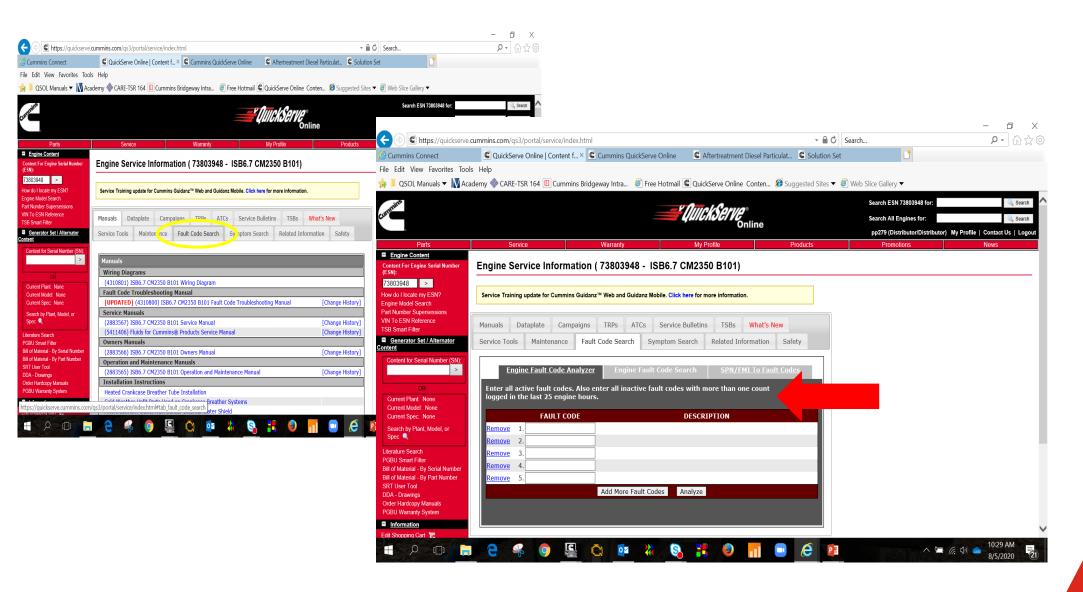
Fault Code Analyzer - QSOL - Enter ESN - FC Search - Enter FC's All Active & IA with more than one count in past 25 hrs

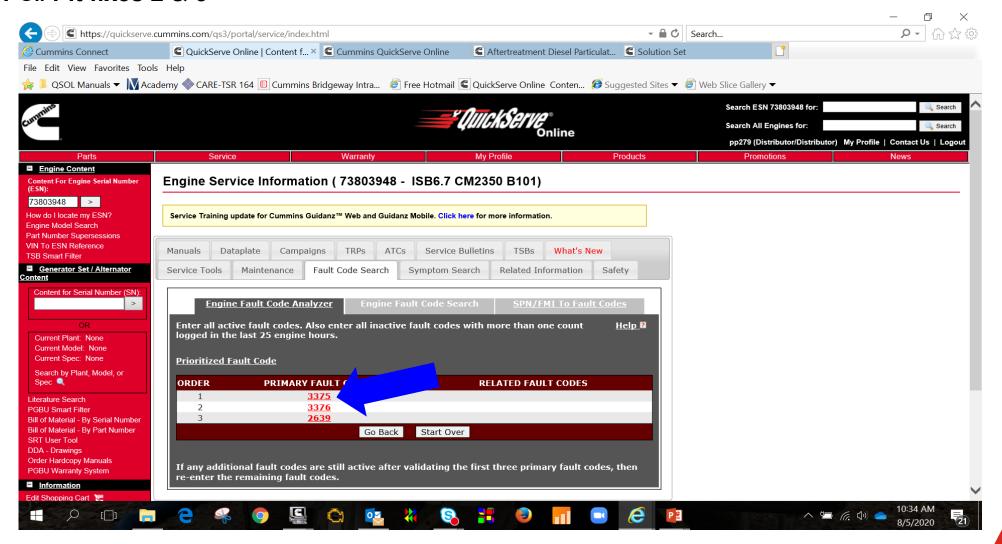
Enter Codes – Hit Analyze Button – In this case, all should FC's should be investigated and completed in the *order listed* 1-2-3 – click the link to the tree - When going through each FC T/shooting, some steps may be covered in prior FC's – Don't assume by fixing FC#1 it fixes 2 & 3

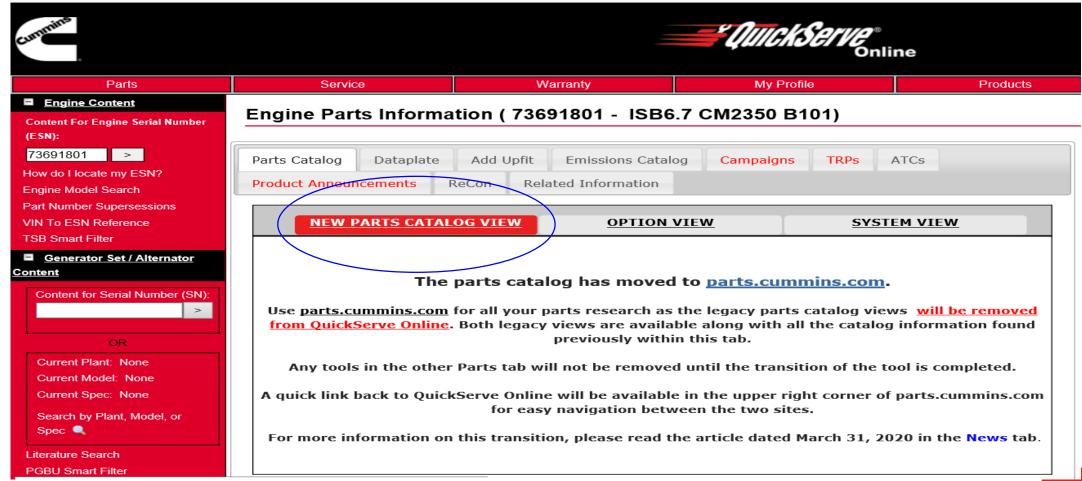
QuickServe - Parts

New Parts Catalog View – parts.cummins.com - We are converting over and the original QSOL parts look-up still works but migrate over

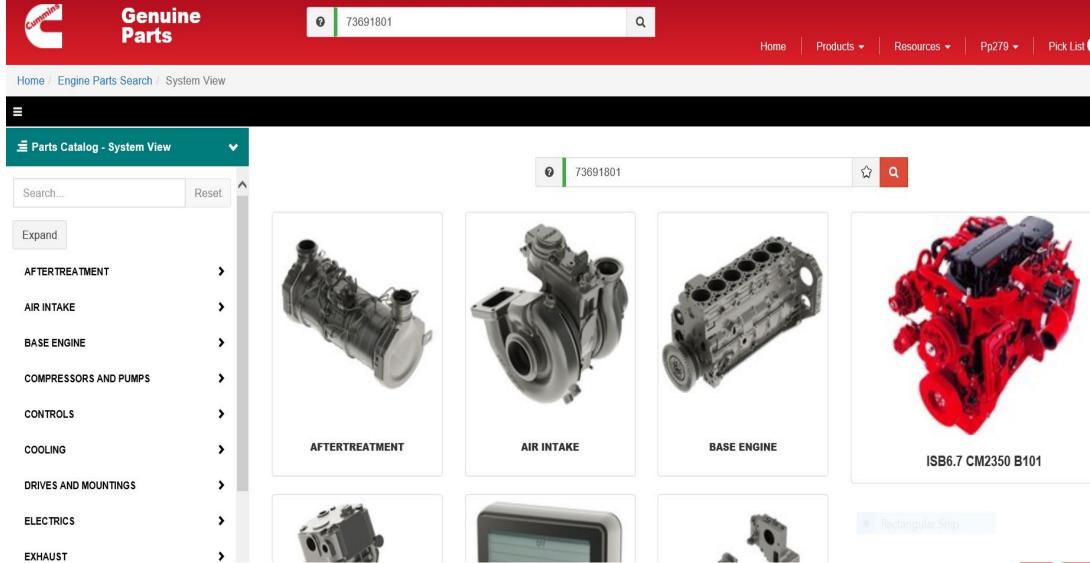
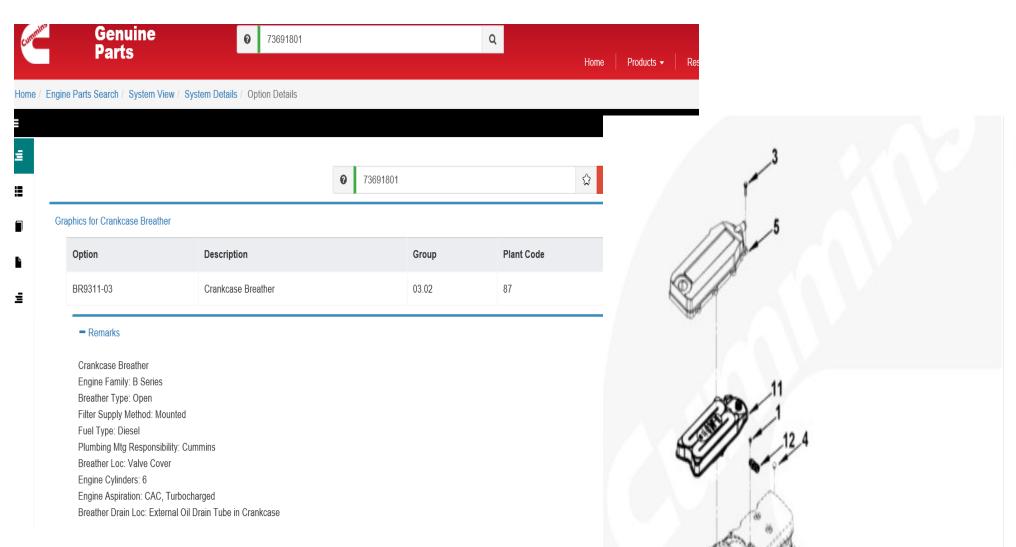
Layout of parts.cummins.com

Ref	Part Number	Description
•	1	3968475	Screw, Hex Flange Head Cap
•	2	3900630	Screw, Hex Flange Head Cap
•	3	3902023	Screw, Hex Flange Head Cap
•	4	3905368	Expansion Plug
•	5	4989994	Breather Cover
•	6	3939258	Cover Plate Gasket
•	7	4931725	Accessory Hole Cover
•	8	4932701	Plain Hose Coupling
•	9	4934496	Plain Hose Coupling
•	10	5255740	Lubricating Oil Drain Tube
•	11	4936636	Breather Element
•	12	4984575	Pressure Sensor
